# 1234 Sample Ridge Road, Evergreen, CO 80439

2026-05-14

## Summary

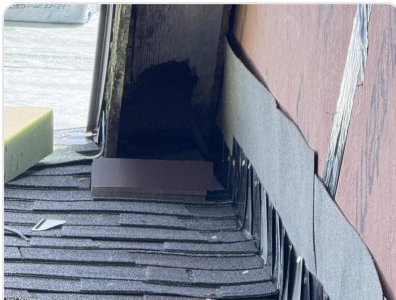
South, West — The architectural asphalt shingles show moderate granule loss and scattered hail bruising on the south- and west-facing slopes, consistent with age (~14 years) and past storm exposure. No active leaks were observed in the attic below. Anticipate replacement planning within the next 3–5 years; have a roofing contractor evaluate after the next significant hail event.

**South, West —** The architectural asphalt shingles show moderate granule loss and scattered hail bruising on the south- and west-facing slopes, consistent with age (~14 years) and past storm exposure. No active leaks were observed in the attic below. Anticipate replacement planning within the next 3–5 years; have a roofing contractor evaluate after the next significant hail event.

South slope — granule loss and scattered hail bruising visible at arrows.

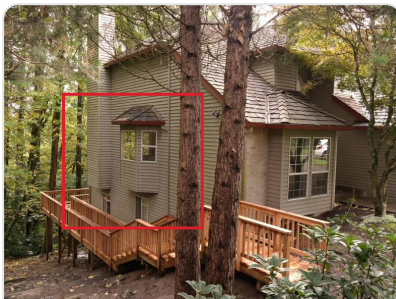
The rear deck guardrail is loose at two posts and moves noticeably under hand pressure, and baluster spacing exceeds 4 inches along the stair run. With a walk-out drop of about 9 feet, this is a fall hazard — repair before the deck sees regular use. The ledger attachment (through-bolted and flashed) is sound.

**SAFETY HAZARD** The rear deck guardrail is loose at two posts and moves noticeably under hand pressure, and baluster spacing exceeds 4 inches along the stair run. With a walk-out drop of about 9 feet, this is a fall hazard — repair before the deck sees regular use. The ledger attachment (through-bolted and flashed) is sound.

Guardrail movement at the boxed posts; baluster spacing >4" at the stairs.

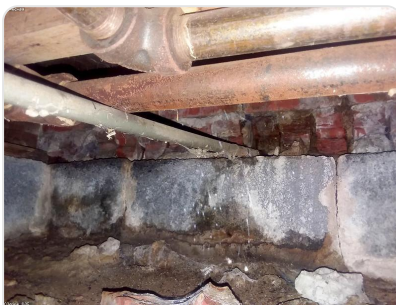
The crawlspace vapor barrier has displaced seams and torn sections exposing bare soil across roughly a third of the area. Re-lap and patch — bare soil pumps ground moisture (and radon) into the house.

**MAINTENANCE** The crawlspace vapor barrier has displaced seams and torn sections exposing bare soil across roughly a third of the area. Re-lap and patch — bare soil pumps ground moisture (and radon) into the house.

Vapor barrier displaced at seams — bare soil exposed.

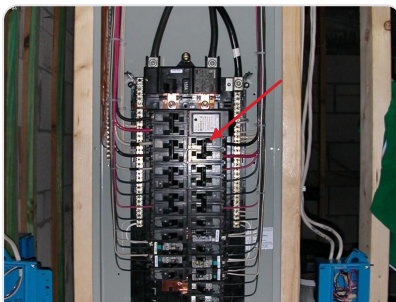
Two circuit conductors are landed under a single breaker lug ("double tap") at breaker #14 in the main panel. The lug is not rated for two conductors; the connection can loosen and overheat. An electrician can correct this quickly by adding a breaker or an approved tandem.

Double-tapped breaker at the arrow (breaker #14).

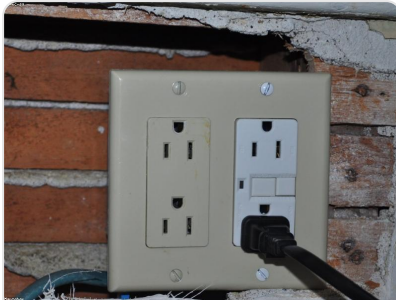
Interior — The kitchen counter receptacles and the hall bathroom receptacle are not GFCI-protected. Ground-fault protection is a meaningful shock safeguard anywhere water and electricity meet. Retrofitting GFCI devices at these locations is inexpensive and recommended.

**Interior** — The kitchen counter receptacles and the hall bathroom receptacle are not GFCI-protected. Ground-fault protection is a meaningful shock safeguard anywhere water and electricity meet. Retrofitting GFCI devices at these locations is inexpensive and recommended.

Kitchen counter receptacle — no GFCI protection present.

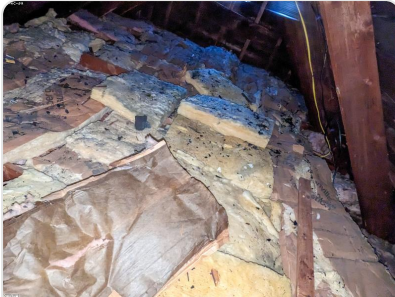
Blown-in insulation averages ~8 inches ( $\approx R-24$ ) — roughly half of the R-49–R-60 recommended for our climate zone. Topping up is a high-payback improvement and the best defense against ice dams. Air-seal attic penetrations first.

Insulation depth ~8" at the ruler — recommend topping up to R-49+.
